**BLACKSTONE RIVER BASIN
AUBURN, MASSACHUSETTS**

**STONEVILLE POND DAM
MA 00126**

**PHASE I INSPECTION REPORT
NATIONAL DAM INSPECTION PROGRAM**

AUGUST 1978

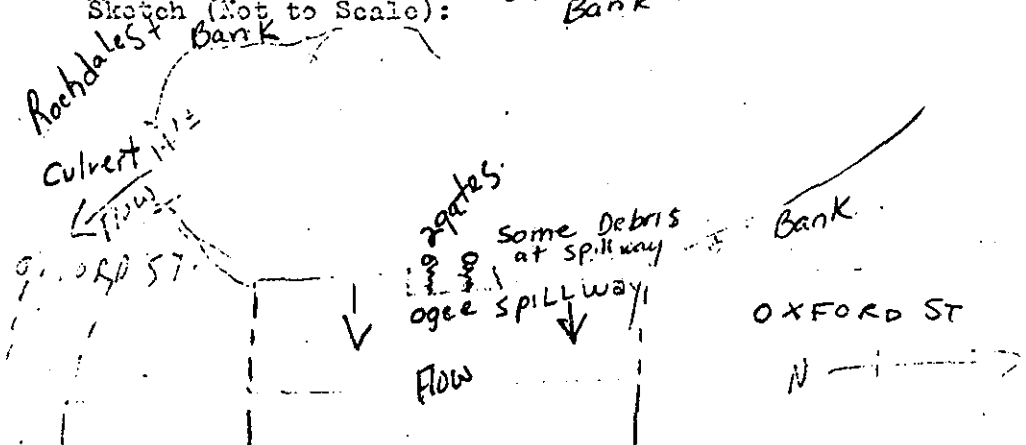
Remarks and Recommendations:
 water flowing about 3" over ogees spillway at time
 of inspection some brush growing near abutments
 concrete scaling at gates
 * GATES APPEAR TO BE INOPERABLE
